Recent Case Studies in Bearing Fault Detection and Prognosis

**Michael Roemer, Carl Byington,
Jeremy Sheldon**

Impact Technologies, LLC
Rochester, NY • State College, PA •
Atlanta, GA

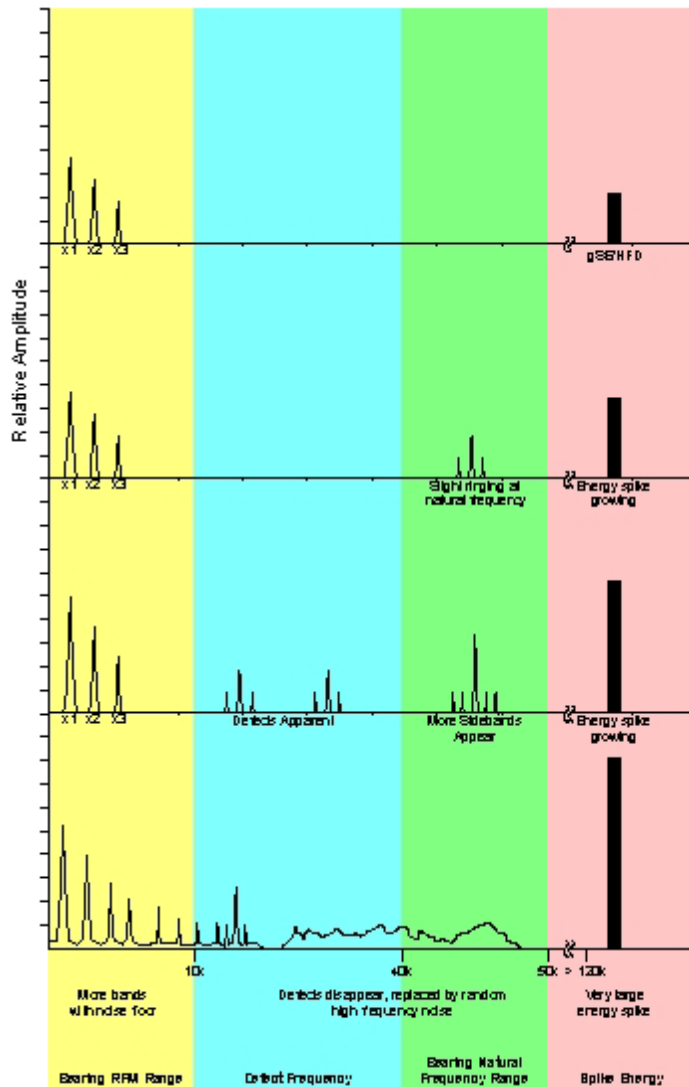
Bearing Failure Mechanism Progression

- ❖ Failure occurs in stages
- ❖ Symptoms start at high frequency excitation and move toward lower frequencies as damage progresses
- ❖ Coupling high frequency vibration techniques with models can provide best confidence in predictions

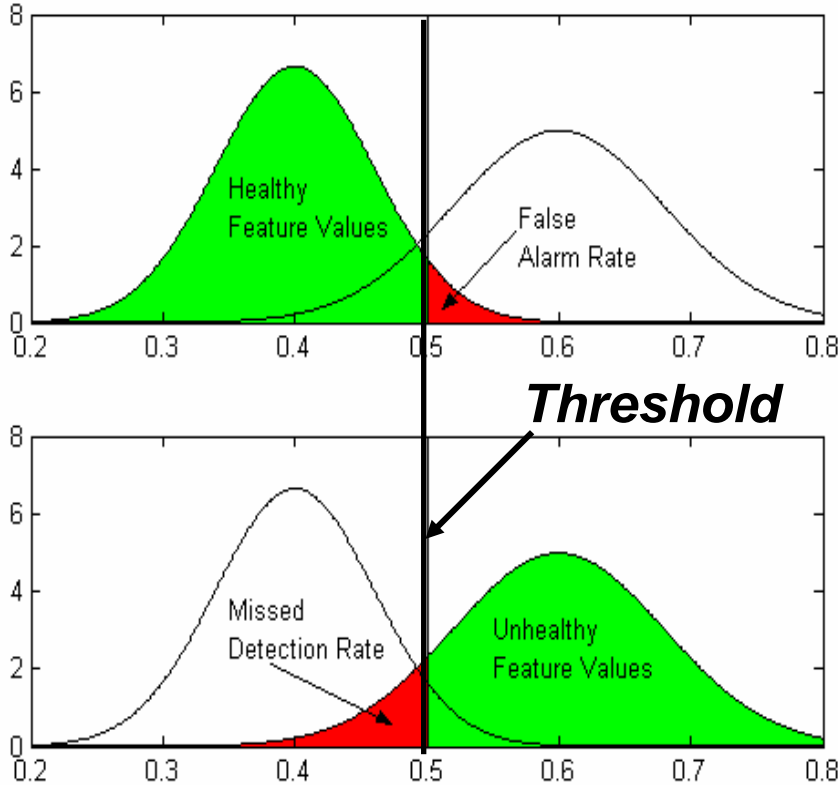
Detection Theory, Uncertainty and Threshold Settings

Feature Distributions

$$P(\text{FA}) = 1 - P(\text{CR})$$
$$P(\text{D}) = 1 - P(\text{MD})$$

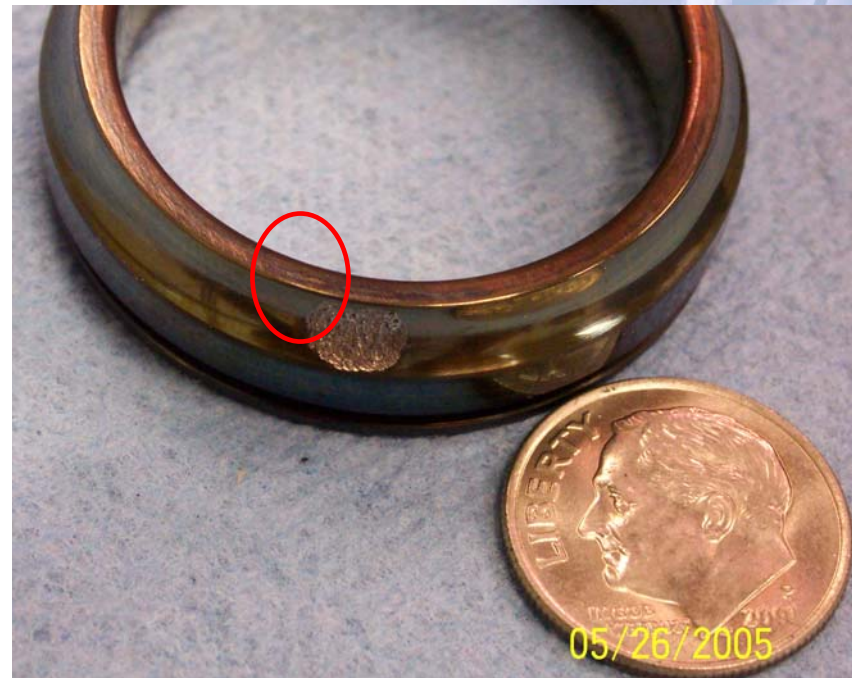
Test Bearing Conditions

Three Bearing Conditions:

◆ Healthy

- Used but in good condition

◆ Dented

- Two Brinell Hardness Indents on inner race
- Inner raceway wear path

◆ Spalled

- Spall initiated in Minisimulator from a Brinell mark on inner race
- Dimensions 0.3 in x 0.25 in
- ~8 hrs at 12,000 RPM

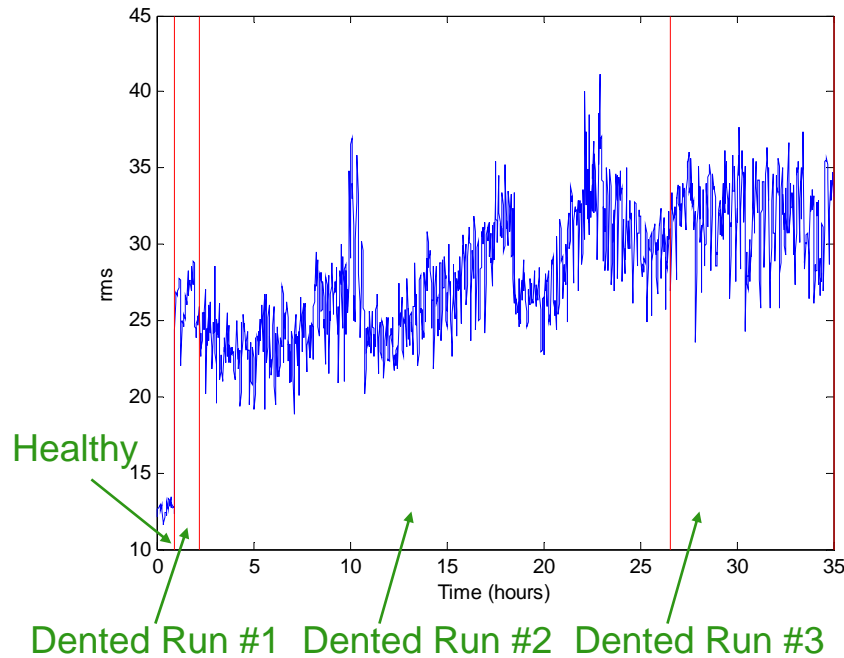
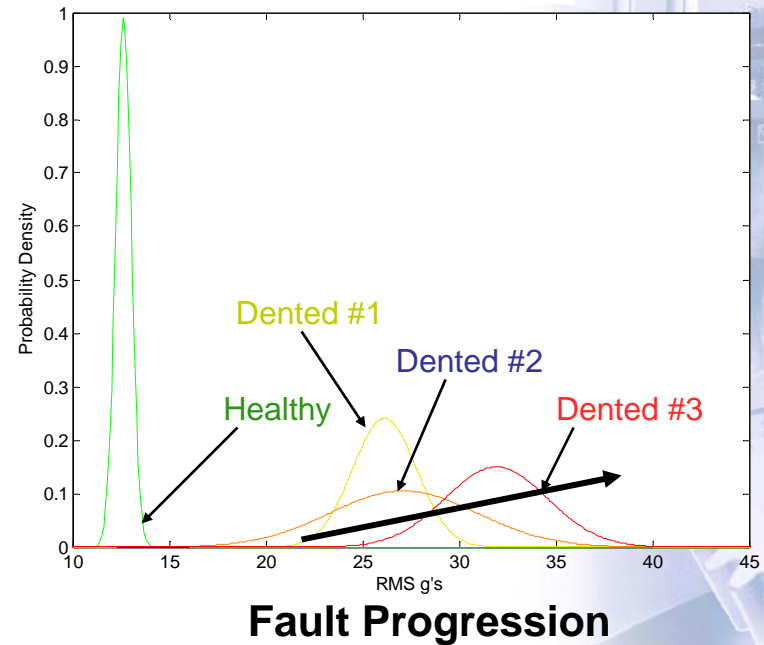
Narrowband Feature

- ◆ Significant reduction in False Alarms
- ◆ Increase in Mean and Variance of faulted distributions

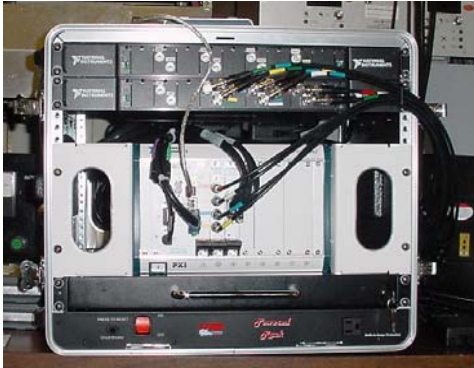
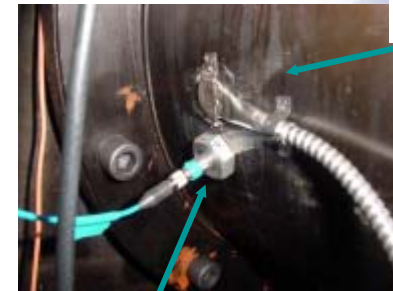
Monitoring System Hardware

Channel	Type	Location	Sampling
1	Accelerometer	12:00 O'Clock	200 kS/s
2	Accelerometer	2:00 O'Clock	200 kS/s
3	Accelerometer	8:00 O'Clock	200 kS/s
4	Accelerometer	10:00 O'Clock	200 kS/s
5	Thermocouple	12:00 O'Clock	5 kS/s
6	Thermocouple	2:00 O'Clock	5 kS/s
7	Thermocouple	8:00 O'Clock	5 kS/s
8	Thermocouple	10:00 O'Clock	5 kS/s
9	Tachometer	Low Spd Shaft	5 kS/s
10	Tachometer	High Spd Shaft	5 kS/s

J -Type Thermocouples

PCB 357B14 Accelerometers

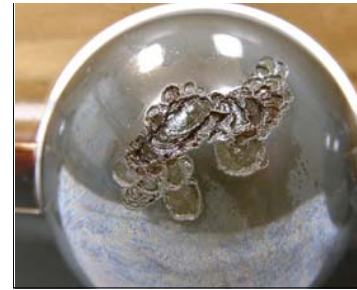
Test Configuration

❖ Ceramic Hybrid Test Bearing

- Silicon nitride rolling elements
- Metallic races
- Angular contact geometry
- Rolling Element Seeded Fault

| ❖ Stage 1 | 100% axial load | 100% speed |
| ❖ Stage 2 | 48% axial load | 93% speed |

- 2 seconds of data every two minutes
- Over 700 GB of data; over 1100 hrs of testing

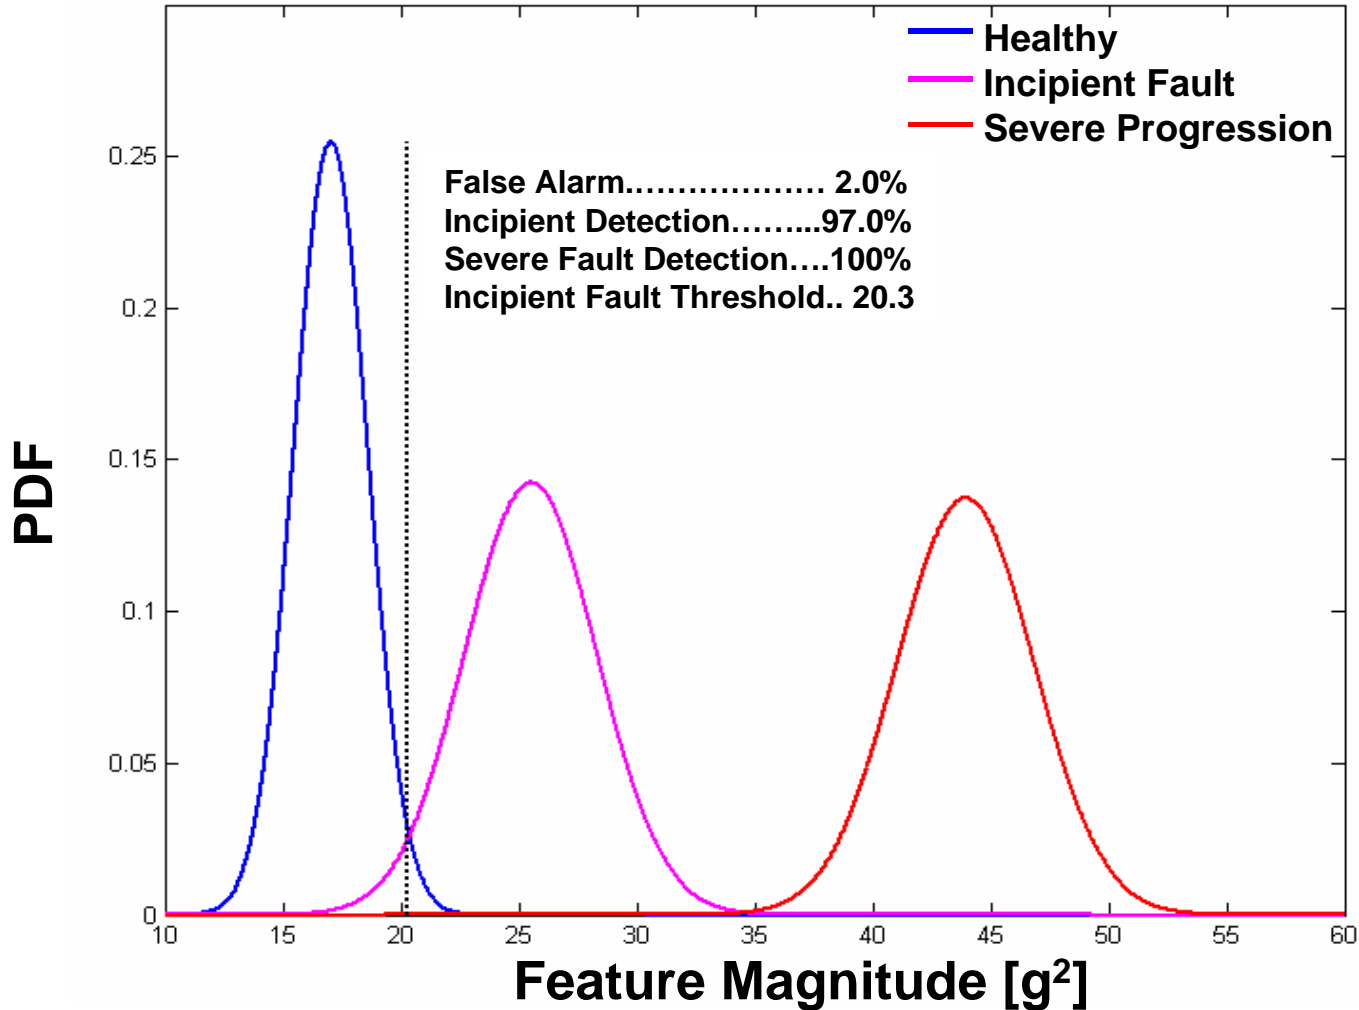
Accelerometer 2 Energy Feature 1

Statistical Detection Analysis

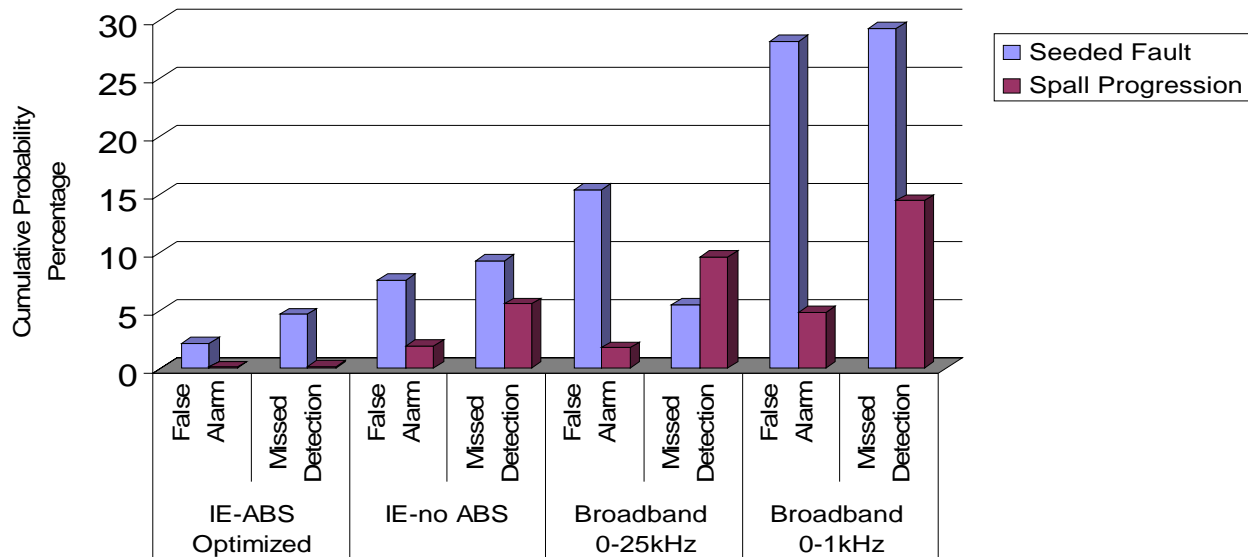
Statistical Fault Detection Summary

- ❖ Vibration-based ImpactEnergy™ processing provides clear race spall detection with high confidence
 - Corroborated by estimate of ground truth and debris measurements
- ❖ Current vibration technology is extensible to hybrid ceramic bearings
- ❖ Technology validated and verified with full scale engine bearing rig through successful detection of a both incipient and severe faults

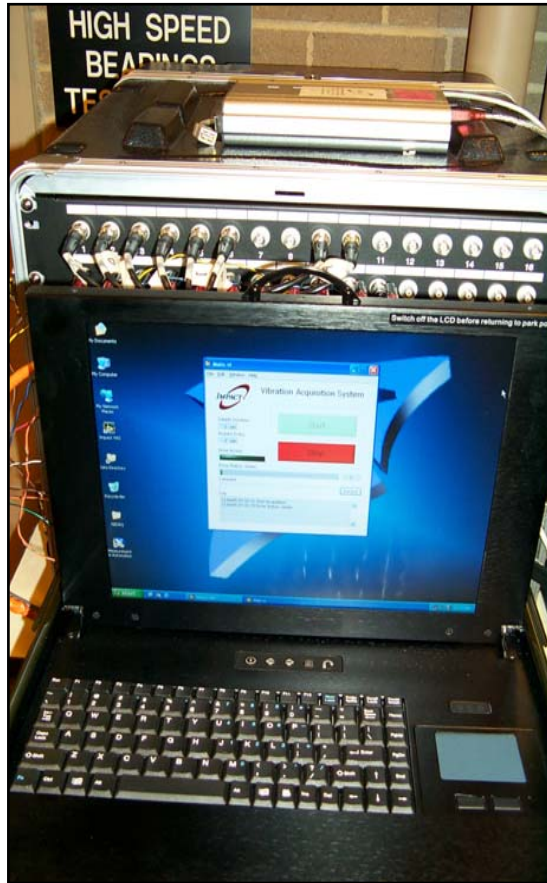
Monitoring System Hardware

DAQ Hardware

Exterior Accelerometer Location G

Exterior Accelerometer Location H

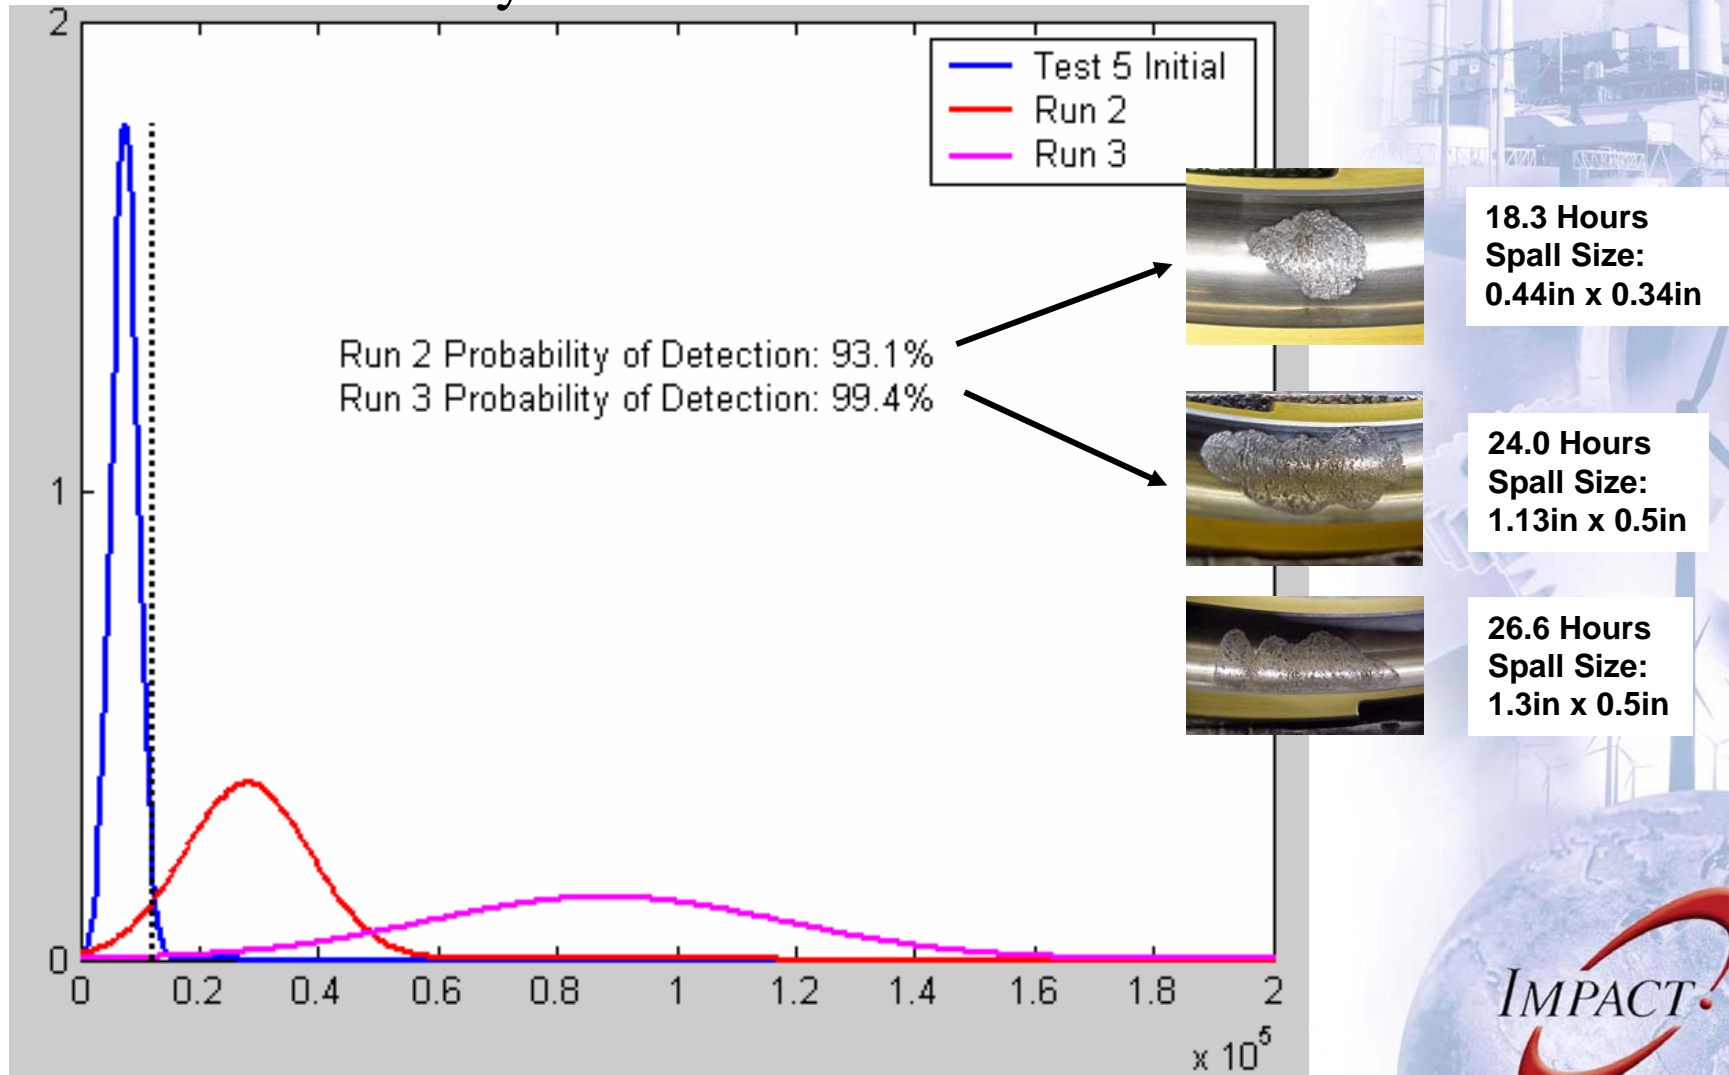
Test 5: Statistical Detection

Outer Race Anomaly Feature

TEST NUMBER	SENSOR	FALSE ALARM	INCIPIENT DETECTION	INCIPIENT DETECTION TIME [HRS]	SPALL DETECTION	SPALL DETECTION TIME [HRS]	TOTAL RUNTIME [HRS]
2	Accel: G	2.0%	82.8%	33.4	99.1%	86.7	174.4
3	Accel: H	2.0%	99.3%	46.7	99.7%	93.3	117.1
4	Accel: H	2.0%	97.4%	8.2	100.0%	9.4	10
5	Accel: G	2.0%	66.8%	5.7	97.2%	20	24.8
6	Accel: G	2.0%	96.1%	33.4	100.0%	82	116.5
7	Accel: H	2.0%	90.9%	25	99.7%	84.2	101.6
10	Accel: H	2.0%	95.6%	23.4	100.0%	93.3	101.6
12	Accel: G	2.0%	97.6%	4.2	97.6%	7.9	8.8
14	Accel: G (Exterior)	2.0%	89.2%	16.7	99.0%	166.7	185.6
14	Accel: F (Interior)	2.0%	96.7%	16.7	100.0%	167.8	185.6

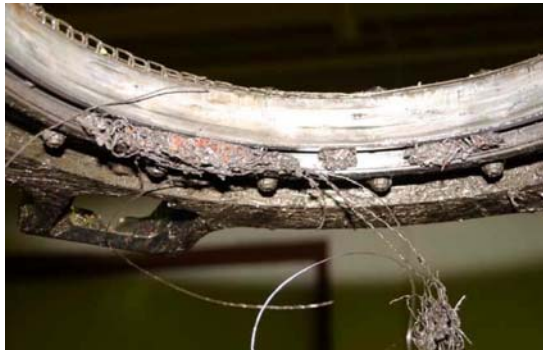
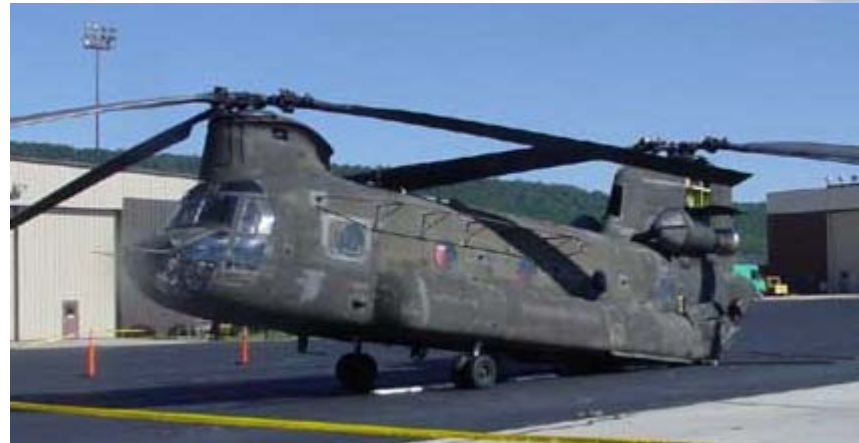
Images: (L) Keller, J., Grabill, P., "Inserted Fault Vibration Monitoring Tests For a CH-47D Aft Swashplate Bearing," American Helicopter Society 61st Annual Forum, June 1-3, 2005. (R) <http://www.chinook-helicopter.com>

- **Case study: Catastrophic failure of CH-47D aft swashplate bearing**
 - ❑ **Class A mishap: Destroyed aircraft—serious safety concerns**
 - ❑ **Motivated an extensive manual inspection of entire 47D/E fleet—significant increases to maintenance workload providing only incomplete results**

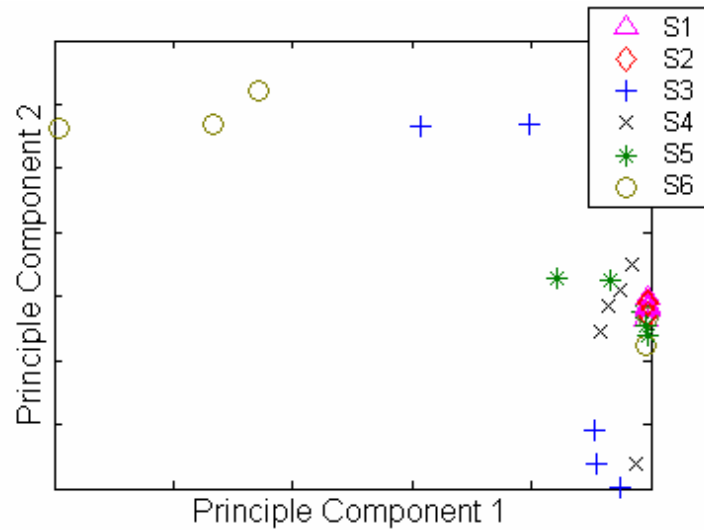
Single Level PCA Attempt

- ❖ PCA performed on entire data set
 - ❖ Several classes with no clear separation
 - ❖ Some classes cluster for a few of the load conditions

A classifier is required that will separate all fault classes while remaining invariant to load condition

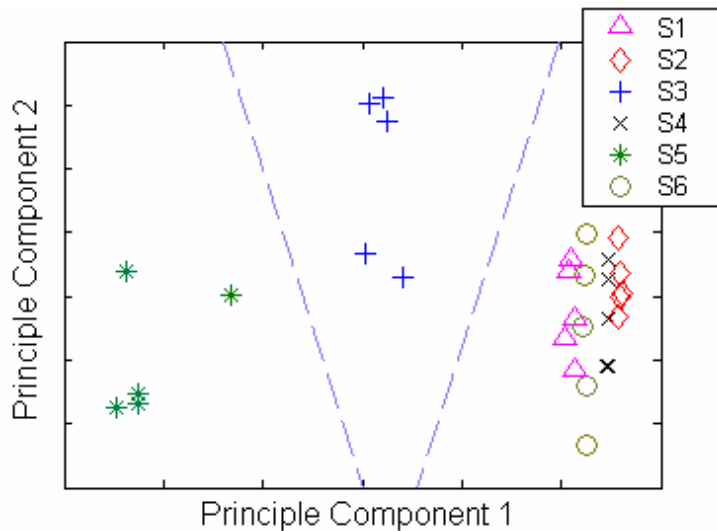
Level 1 Classifier

- ❖ First level: most separable classes - corroded (S3), spalled (S5)
- ❖ Remove classified faults from analysis
- ❖ Second level: refined classifier for cage faults – cage pop (S4), cage overlap (S6) from healthy specimens (S1) & (S2)
